INSPECTOR IAN

COMMERCIAL PROPERTY INSPECTION REPORT # xxxx

Date of Inspection: June 13 , 2009

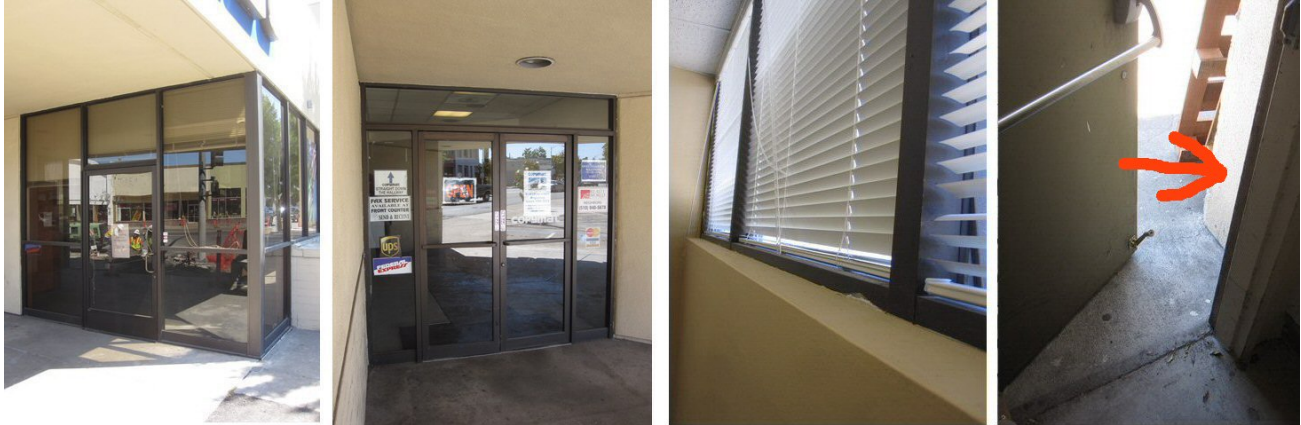
Comments: Windows are aluminum-framed fixed-panel units. The overall condition of the windows was noted to be serviceable with some deterioration of the rubber material around window panes. The fire escape door jamb at the right was loose.

Recommendations: It would be advisable to make repairs to the fire escape door jamb. It would be advisable to monitor the condition of attic windows in wet conditions; any leaks at attic windows should be repaired.

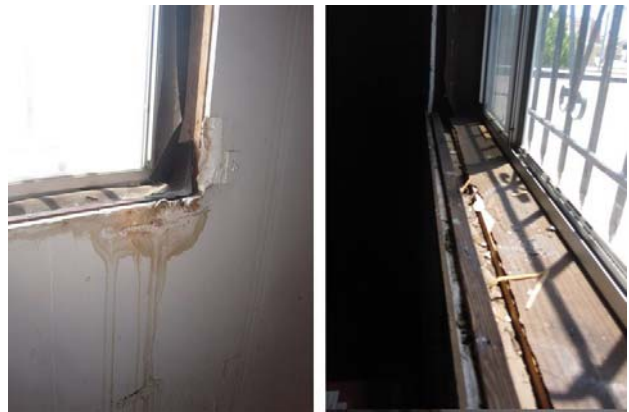
There were signs of water intrusion at windows in the attic area. These areas were dry at the time of the inspection.

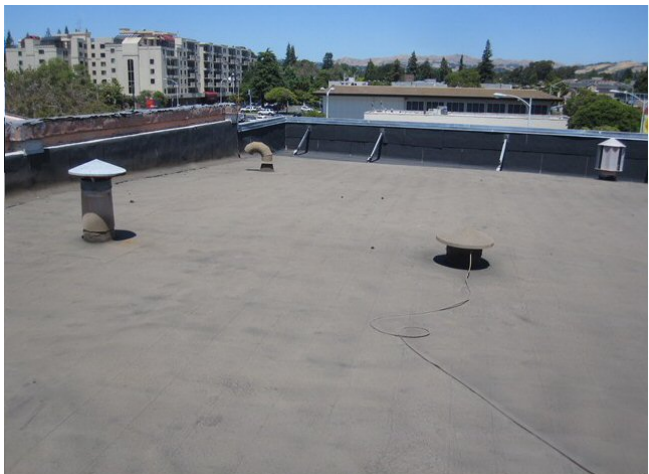
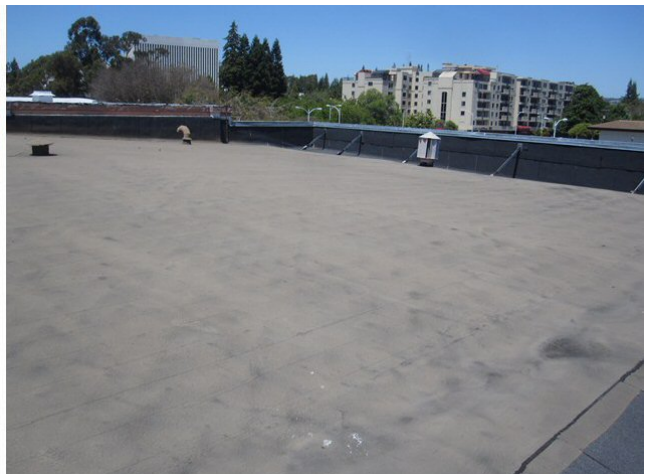
Comments: The lower roof covering was found to be in adequate to poor condition. This type of roof covering consists of several layers of waterproof membrane material which are stuck or nailed over sheets of plywood. Sheets are usually overlapped and sealed with hot bitumen (tar) so that no nail heads or edges of sheets are exposed.

The covering is sloped so that water falling onto the roof is directed to drains in the front and rear corners for the roof (right). Some sediment was noted close to the roof drains: this is indicative of water pooling in these areas. Cracks in the covering were noted throughout the roof (examples below). In addition, there were sever examples of lifted and/or poorly sealed seams at sheet edges.

Recommendations: It would be advisable to replace the roof covering.

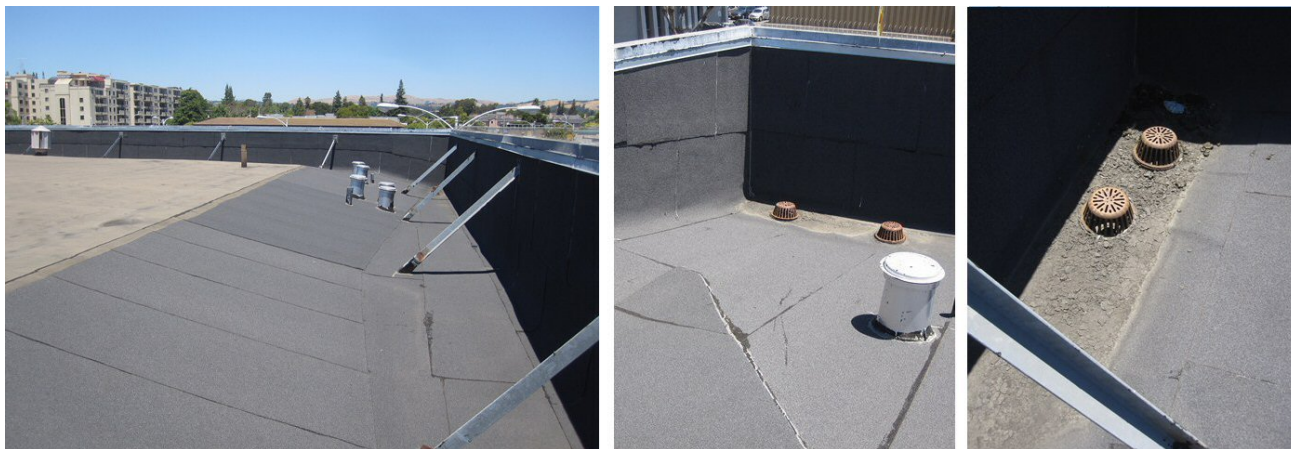
Comments: The upper roof covering was a similar style to the lower roof with a slightly steeper slope directly leading to drainage areas.

Recommendations: It would be advisable to replace the roof covering. Rotten wood in the trim area should be replaced and covered with roofing material to prevent water penetration of the building.

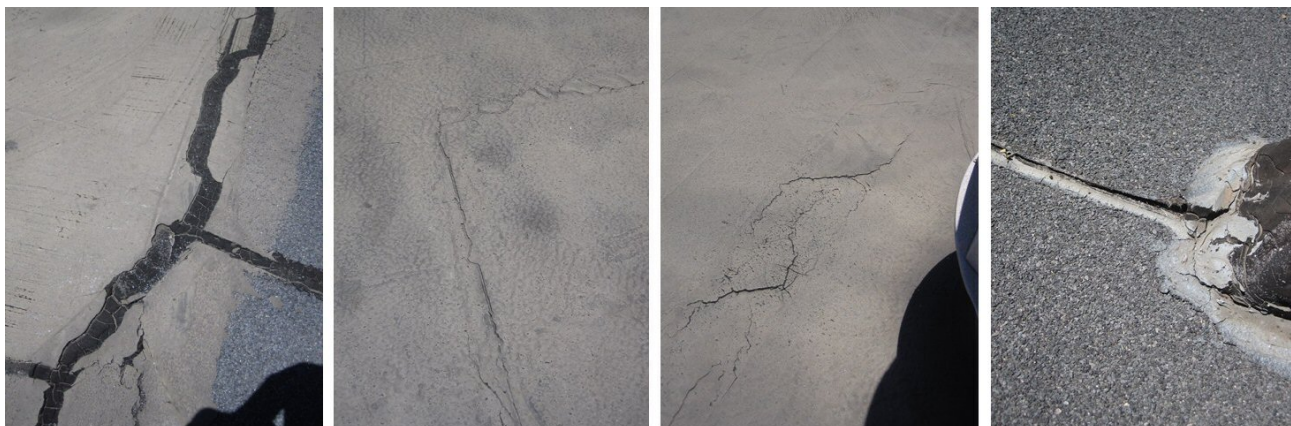
The condition was also similar with cracks in the covering and lifted and/or poorly sealed seams evident throughout the upper roof.

Trim at the NW edge of the upper roof was rotten (right).

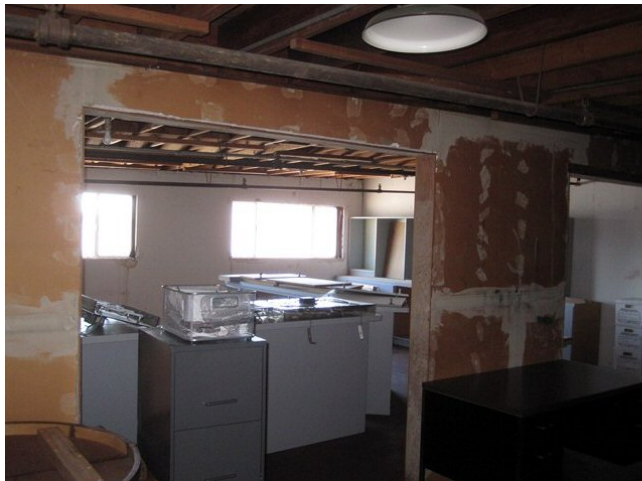
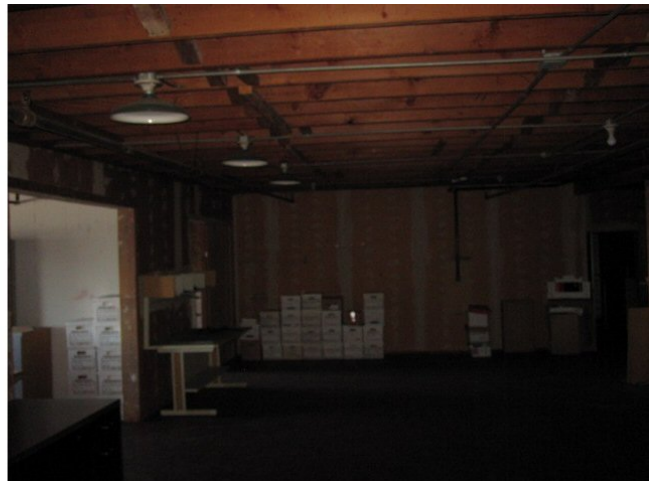
There were signs of water staining in several areas of the under-side of the roof (right). The attic stairs/fire escape was found to be in serviceable condition.

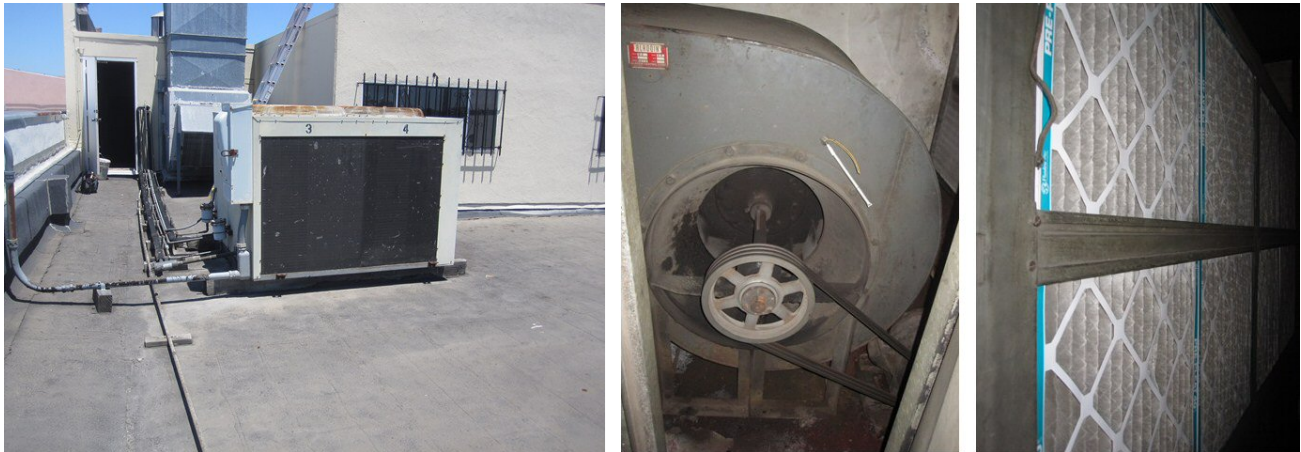
The air conditioning section of the system was operating at half of capacity, as evidenced in several ways. Only one of the two refrigerant lines was accumulating condensation and/or frost as applicable. In addition only two of the fans at the four-fan evaporator station were giving off warm air.

Recommendations: Inspection of the HVAC system by a specialist familiar with this type of equipment would be advisable.

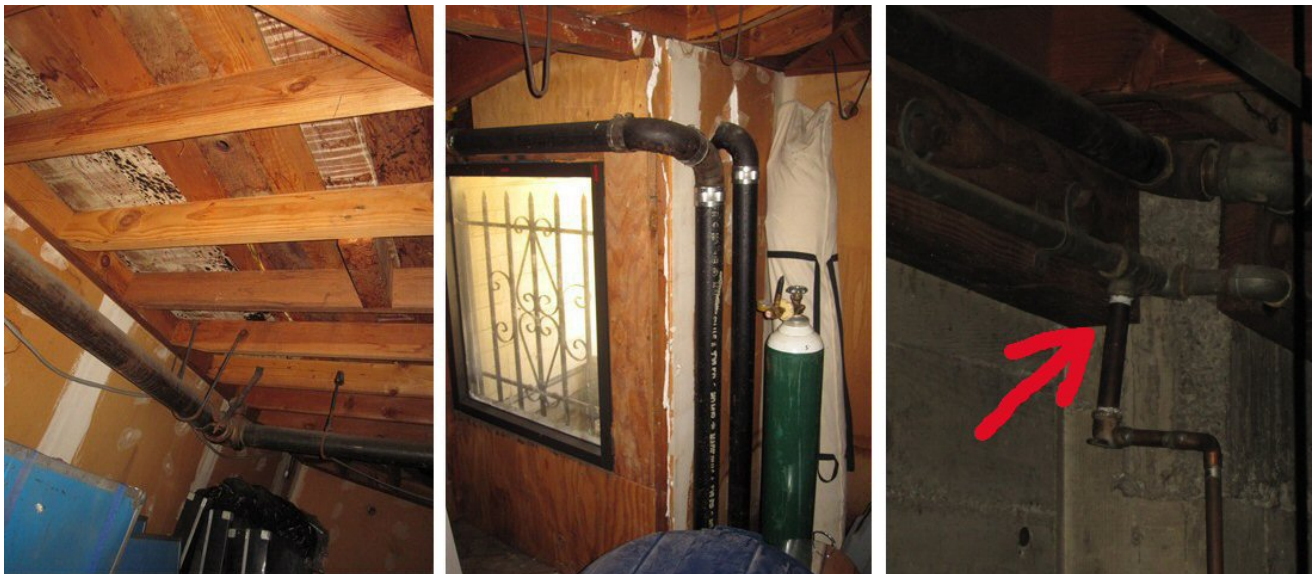
Comments: Pipes were examined where visible, which was restricted to portions below sinks inside the building and in the attic areas. No evidence of any defect was noted in the areas observed. Roof drainage lines are mainly cast iron with some replacement pipe also present. Supply piping was a mixture of copper and galvanized with several direct connections.

Recommendations: It would be advisable to upgrade supply piping to copper throughout the building.

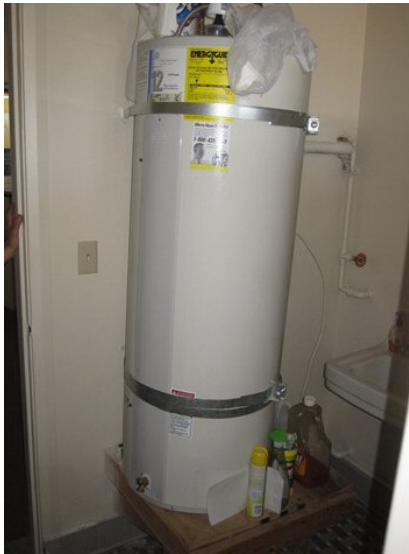
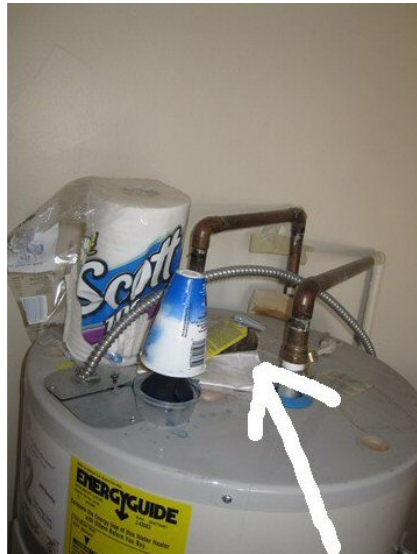
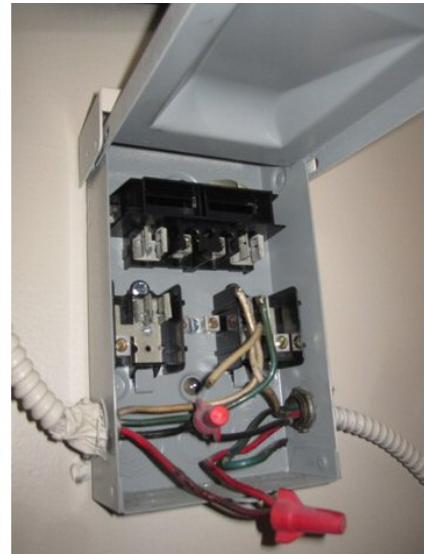
Comments: The water heater was found to be in dangerous condition. The water heater is loose inside the seismic restraining straps. The heater is equipped with a temperature/pressure (T/P) relief valve (below center). This is an important safety device and should not be tampered with. Extension piping is missing from the T/P release valve. The heater has been directly wired to the electricity supply, bypassing the fuse box. The ground connection has been removed. This is extremely dangerous.

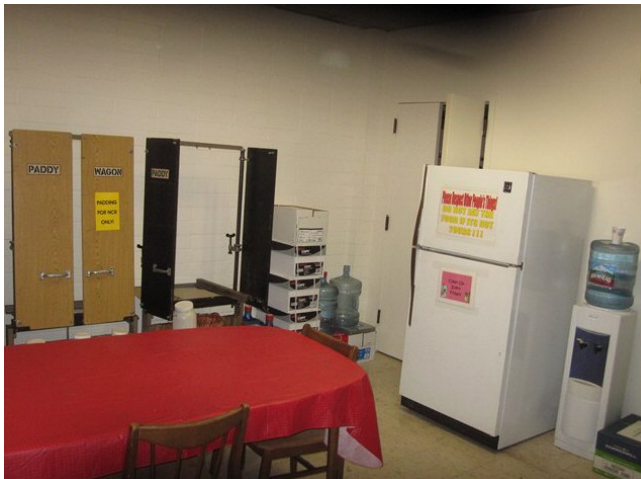
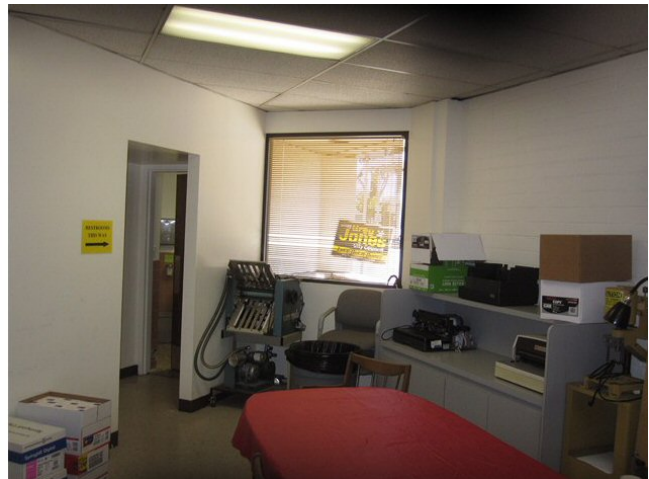
The sink in the break room kitchenette was slow to drain (below right).

Recommendations: It would be advisable to unblock the sink in the kitchenette.

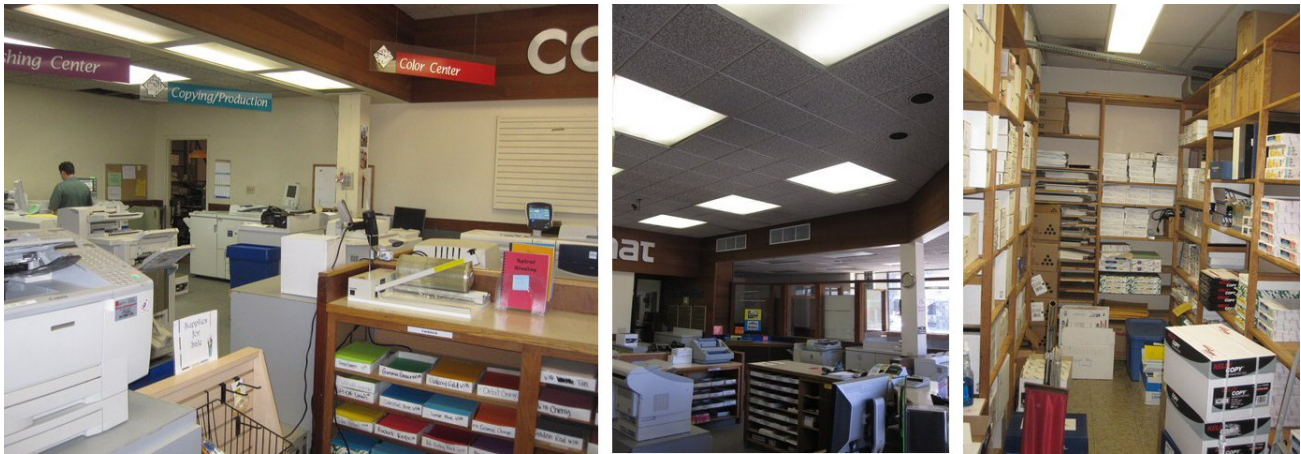
Ceilings in the store room were heavily water stained (below). There were signs of water damage on the underside of insulation in this area. The overall condition of the interior doors was noted to be adequate; one damaged door catch was noted. No sloping floors were noted; floor coverings and furniture items prevented a full inspection of floors.

Recommendations: It would be advisable to replace damaged door catch and make repairs to the ceiling.

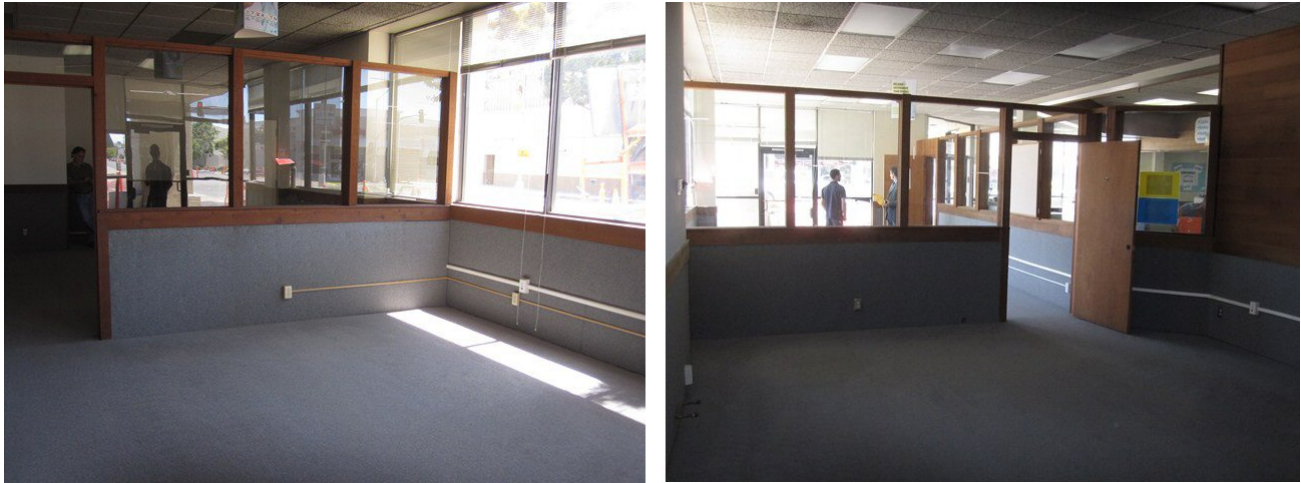
Ceilings towards the center were heavily water stained. Examination revealed water damage on insulation below the roof (below).

Recommendations: It would be advisable to remove or complete the plumbing installation. It would be advisable to replace missing door furniture. Repairs to the ceiling would be advisable.

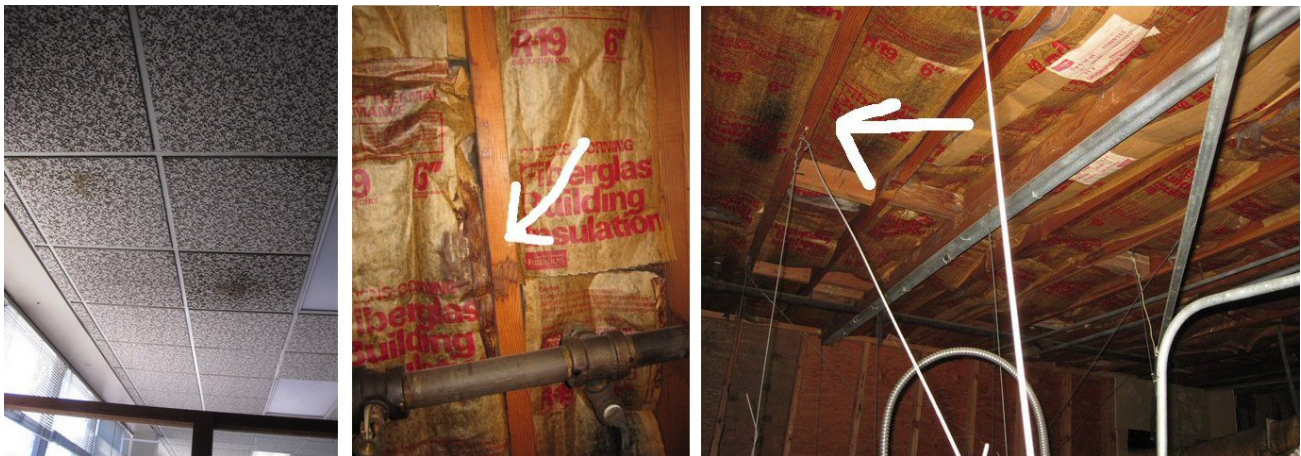
A plastic-lined box was located between the suspended ceiling at the underside of the roof - this is excellent evidence that the roof leaks in under wet conditions. What may be additional water damage was noted at the base of the exterior wall in the rear of the unit (right).

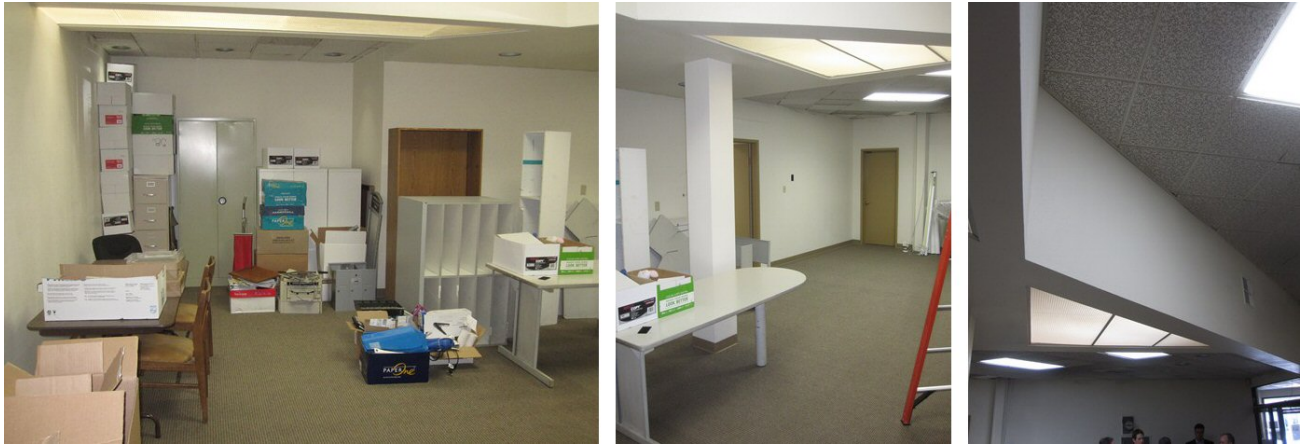
There was some minor damage to the wall in the smaller rooms at the rear of the unit. The door furniture was missing on one interior door.

Recommendations: It would be advisable to replace missing door furniture and repair damage to the walls.

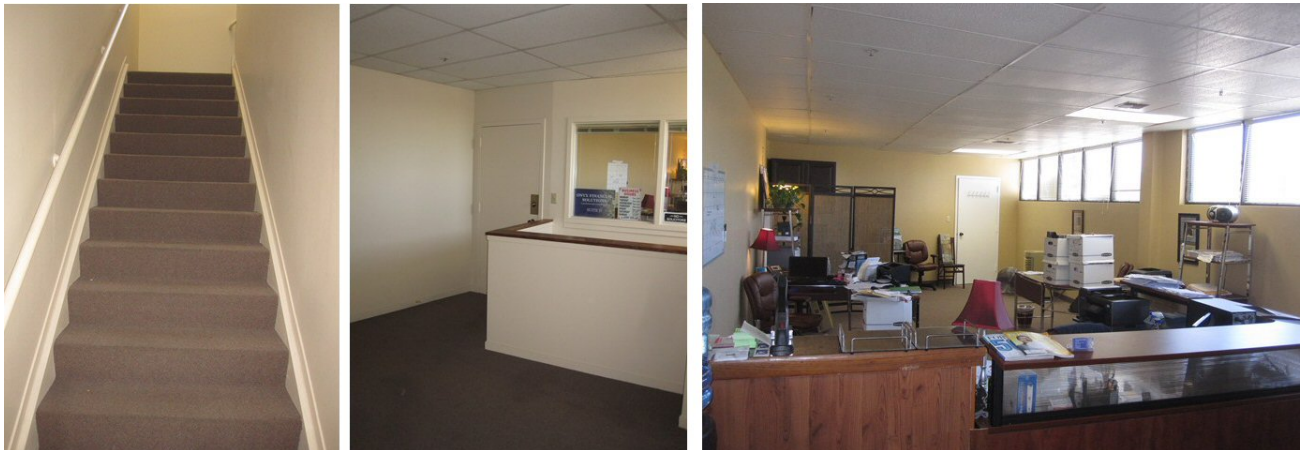
Ceilings at the top of the entrance stairs were heavily water stained (below). There were signs of water damage on the underside of insulation in this area.

Recommendations: see Roof section, above
