INSPECTOR IAN

COMMERCIAL PROPERTY INSPECTION REPORT # xxxx

Date of Inspection: June 13 , 2009

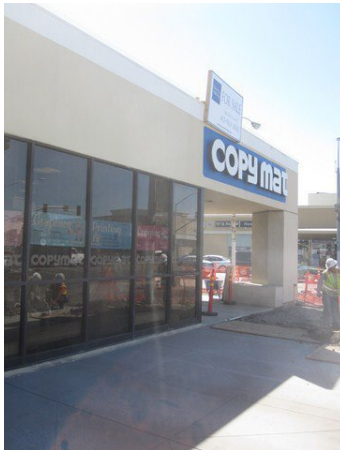
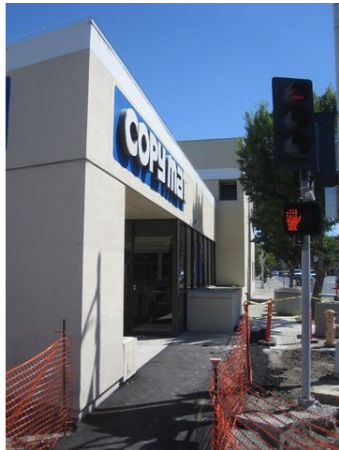
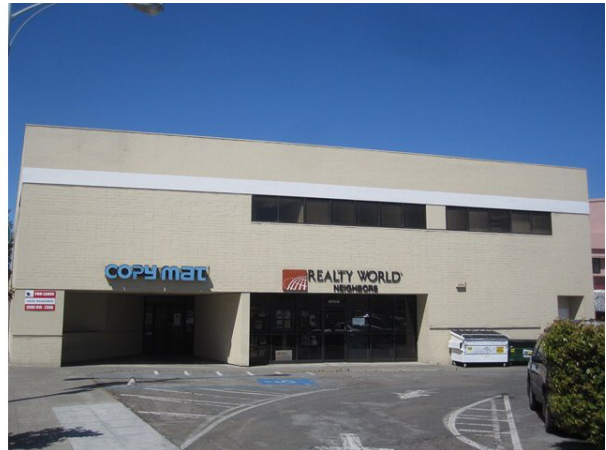
Comments: Windows are aluminum-framed fixed-panel units. The overall condition of the windows was noted to be serviceable with some deterioration of the rubber material around window panes. The fire escape door jamb at the right was loose.

Recommendations: It would be advisable to make repairs to the fire escape door jamb. It would be advisable to monitor the condition of attic windows in wet conditions; any leaks at attic windows should be repaired.

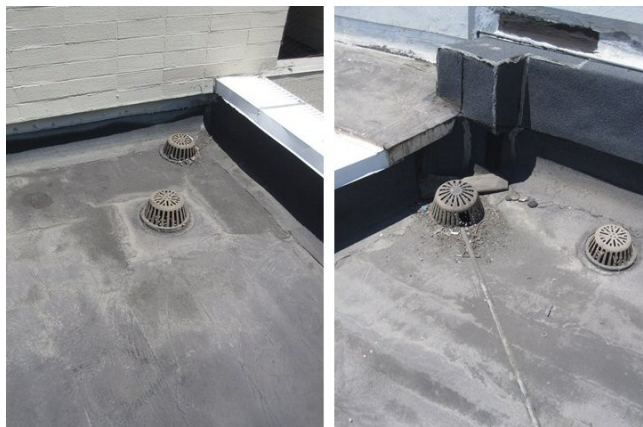
The covering is sloped so that water falling onto the roof is directed to drains in the front and rear corners for the roof (right). Some sediment was noted close to the roof drains: this is indicative of water pooling in these areas. Cracks in the covering were noted throughout the roof (examples below). In addition, there were sever examples of lifted and/or poorly sealed seams at sheet edges.

Recommendations: It would be advisable to replace the roof covering.

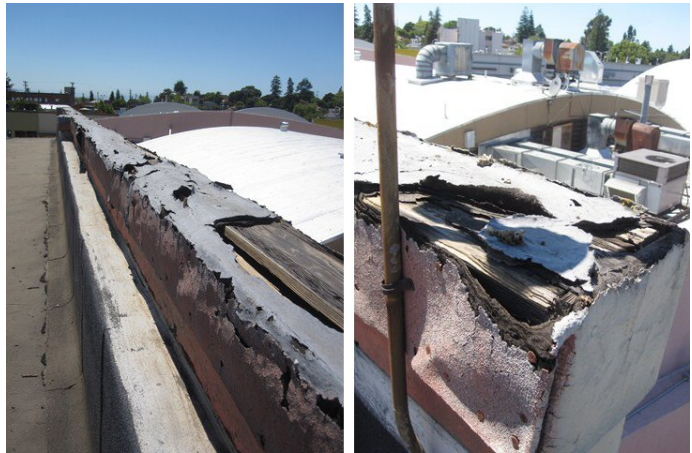
The condition was also similar with cracks in the covering and lifted and/or poorly sealed seams evident throughout the upper roof.

Trim at the NW edge of the upper roof was rotten (right).

Recommendations: It would be advisable to replace the roof covering. Rotten wood in the trim area should be replaced and covered with roofing material to prevent water penetration of the building.

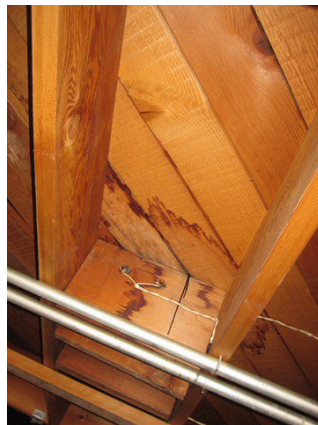
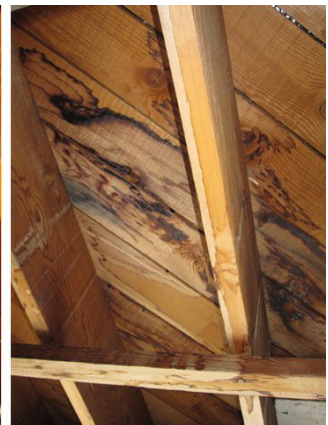
There were signs of water staining in several areas of the under-side of the roof (right). The attic stairs/fire escape was found to be in serviceable condition.

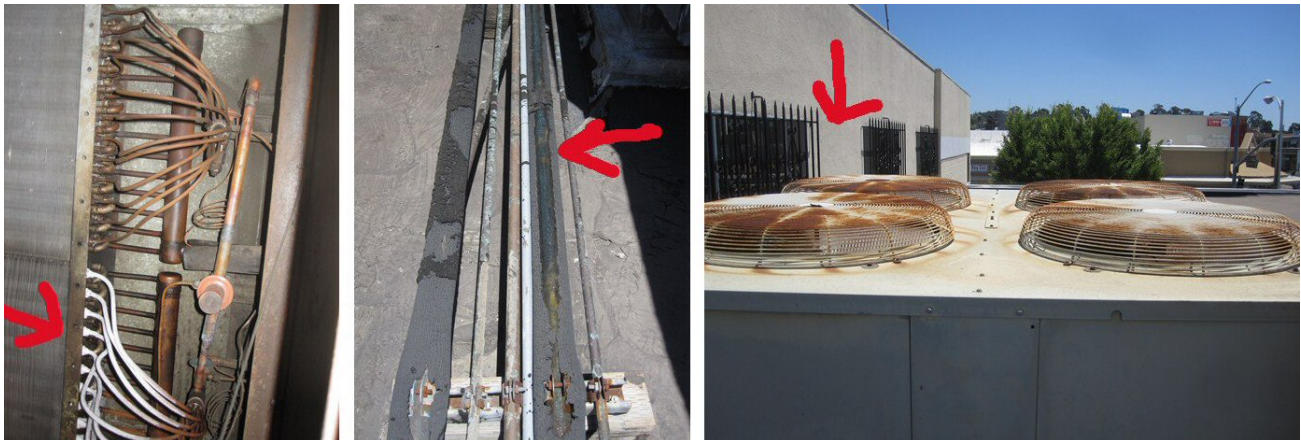
The air conditioning section of the system was operating at half of capacity, as evidenced in several ways. Only one of the two refrigerant lines was accumulating condensation and/or frost as applicable. In addition only two of the fans at the four-fan evaporator station were giving off warm air.

Recommendations: Inspection of the HVAC system by a specialist familiar with this type of equipment would be advisable.

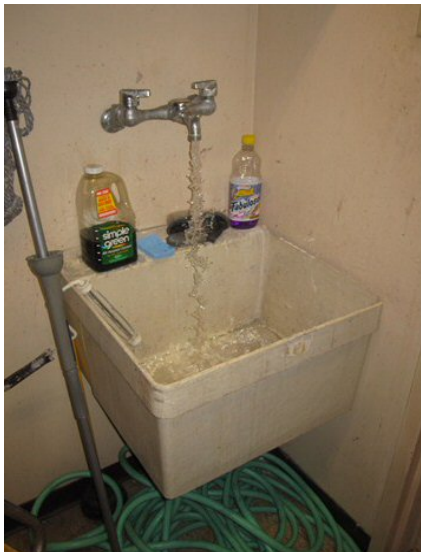
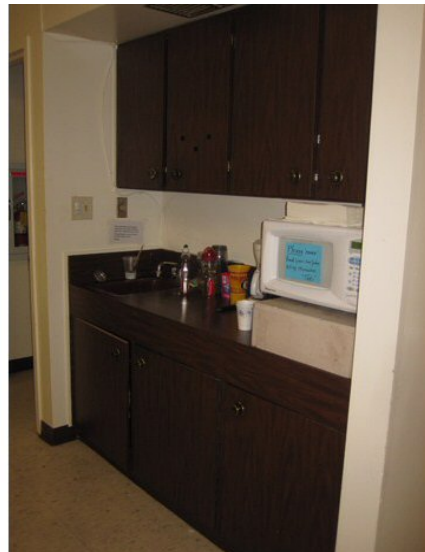
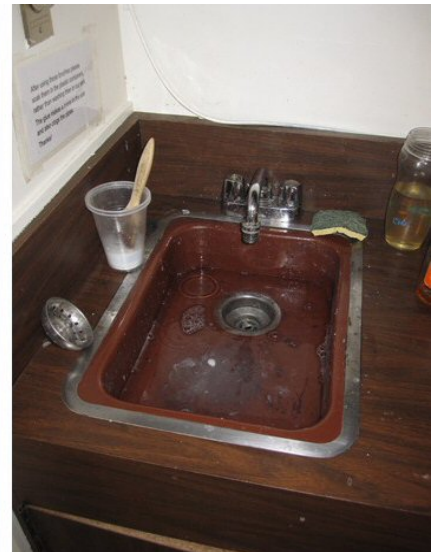
The sink in the break room kitchenette was slow to drain (below right).

Recommendations: It would be advisable to unblock the sink in the kitchenette.

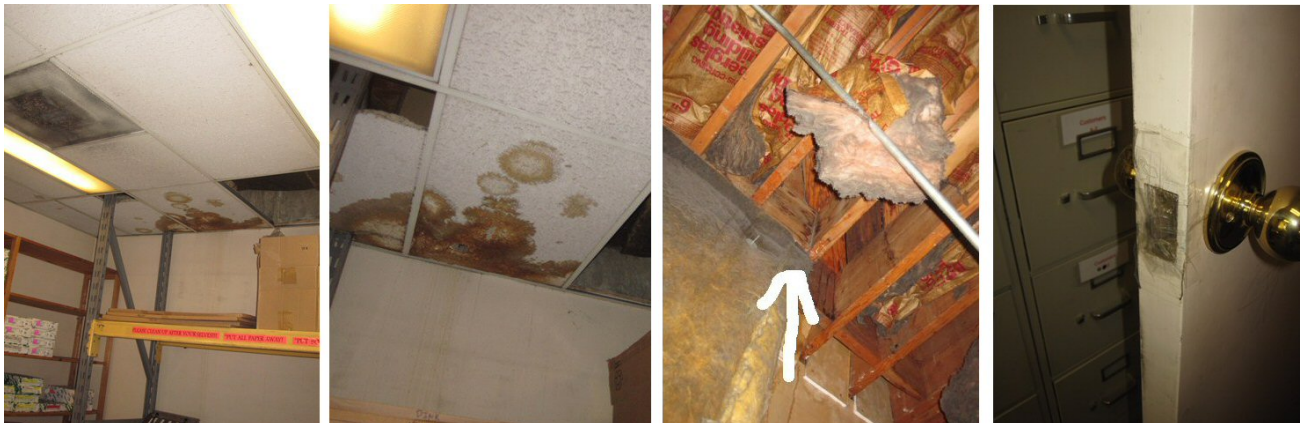
Ceilings in the store room were heavily water stained (below). There were signs of water damage on the underside of insulation in this area. The overall condition of the interior doors was noted to be adequate; one damaged door catch was noted. No sloping floors were noted; floor coverings and furniture items prevented a full inspection of floors.

Recommendations: It would be advisable to replace damaged door catch and make repairs to the ceiling.

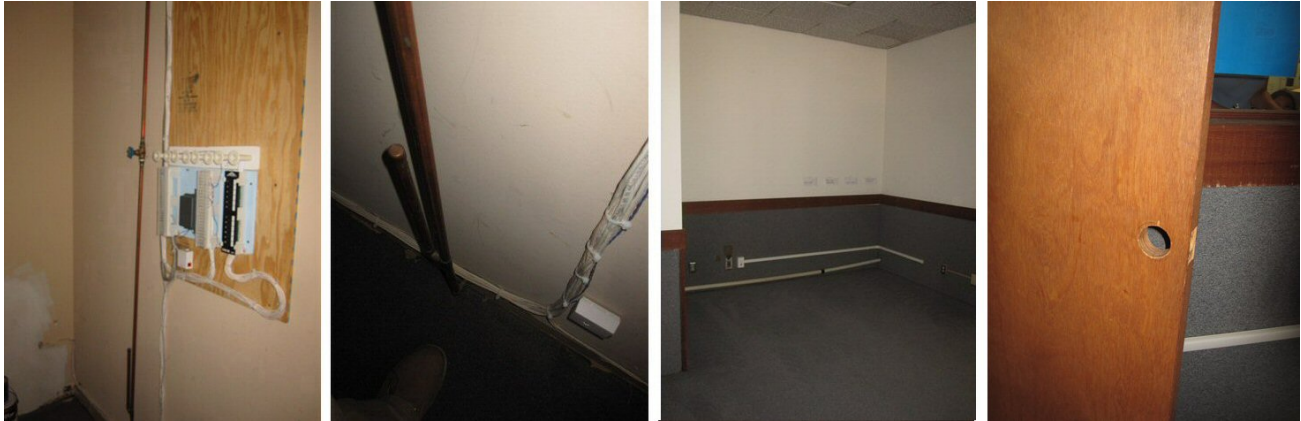
Ceilings towards the center were heavily water stained. Examination revealed water damage on insulation below the roof (below).

A partial plumbing installation has commenced in the rear closet (below). Both the pvc drain line and copper supply piping were loose and poorly installed. It was not clear if this plumbing was actually connected to the main system. The central door in the unit was missing the door furniture.

Recommendations: It would be advisable to remove or complete the plumbing installation. It would be advisable to replace missing door furniture. Repairs to the ceiling would be advisable.

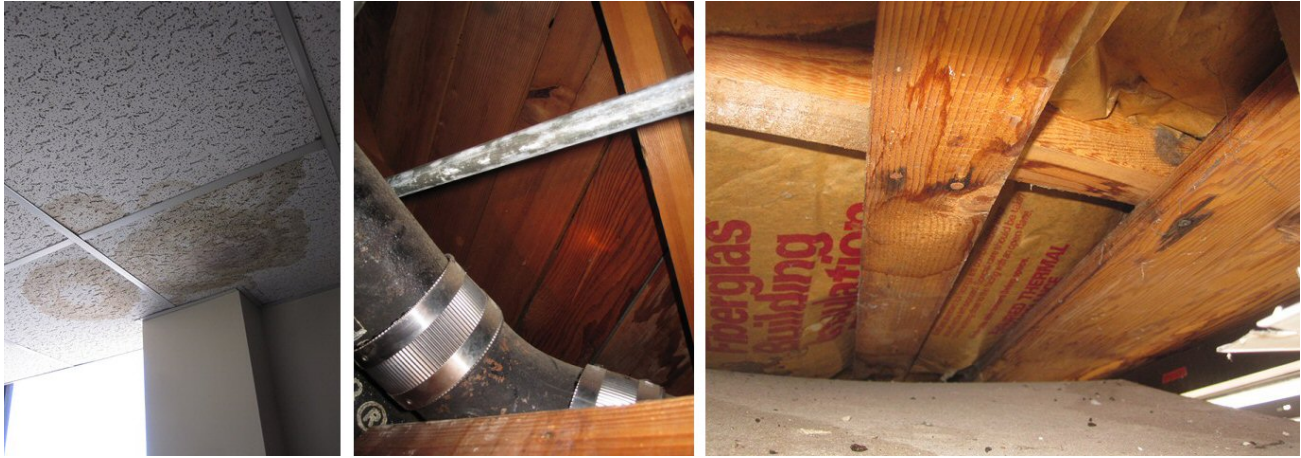
Ceilings at the top of the entrance stairs were heavily water stained (below). There were signs of water damage on the underside of insulation in this area.

Recommendations: see Roof section, above
